Manhole Inspection Summary

Manhole # S59Q__008MH

Location Address: **4201 boston st**

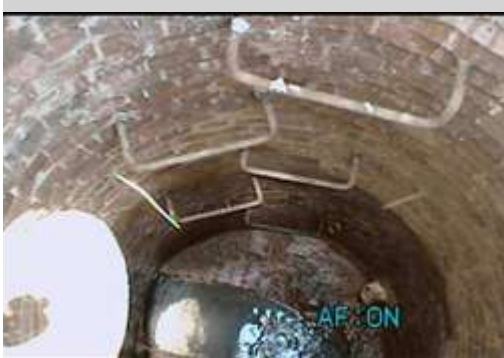
Defect 2

Count: **5** Missing: **0** ☒ **Corroded**

steps

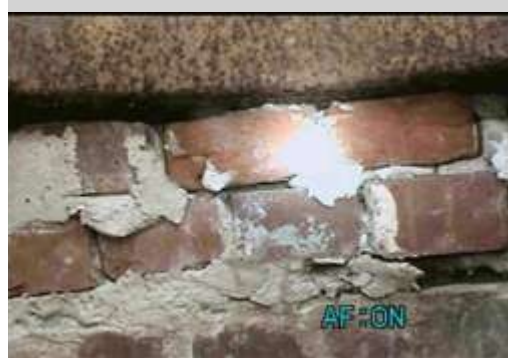
Defect 1

Condition: ☐ Sound ☐ Cracked ☐ Root Intrusion ☒ **Loose Brick** ☐ Deteriorated

Chimney loose bricks,
frame adj

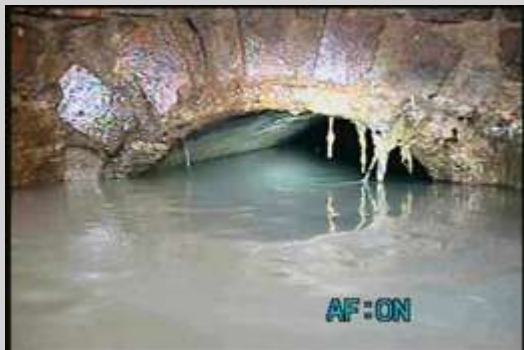
12 O'Clock Outflow

15 in. Circular Gravity Sewer
Pipe Out @ 12 O'Clock

Pipe Material: **Clay** ☐ Pipe Lined

Invert Depth: **10.20** (ft.) Flow Characteristics: **Fast**

Infiltration: **None** Pipe Seal Cond: **Unknown**

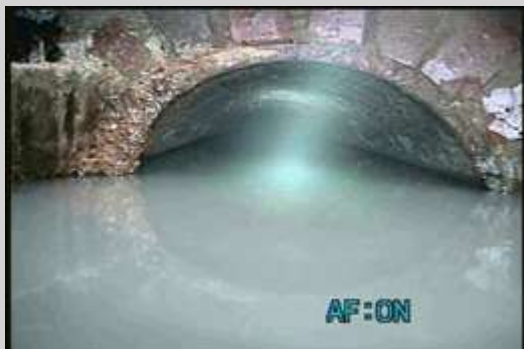
5 O'Clock Inflow

15 in. Circular Gravity Sewer
Pipe In @ 5 O'Clock

Pipe Material: **Clay** ☐ Pipe Lined

Invert Depth: **10.00** (ft.) Flow Characteristics: **Fast**

Infiltration: **None** Pipe Seal Cond: **Unknown**

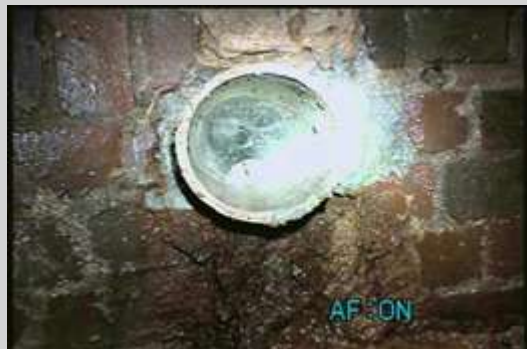
9 O'Clock Inflow

6 in. Circular Gravity Sewer
Pipe In @ 9 O'Clock

Pipe Material: PVC ☐ Pipe Lined

Invert Depth: 9.00 (ft.) Flow Characteristics: None

Connects To: House connection / Service line
